Case Report

Magnetic Resonance Imaging to Evaluate Osteolysis Around Total Knee Arthroplasty

Timothy J. Mosher, MD,* and Charles M. Davis III, MD, PhD†

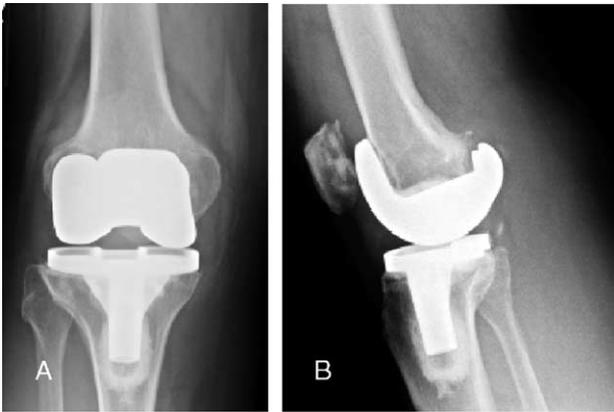
Fig. 1. A, Anteroposterior x-ray demonstrating in satisfactory alignment without evidence of osteolysis. B, Lateral x-ray demonstrating well-fixed components in mild hyperextension with slight lucency in the central distal femur.

Radiographs demonstrated mild recurvatum with effusions of each knee and perhaps some slight lucency in the distal femur on the lateral view of the right knee (Fig. 1). As the physical examination changes of increased hyperextension, instability, and cyst formation as well as the lateral

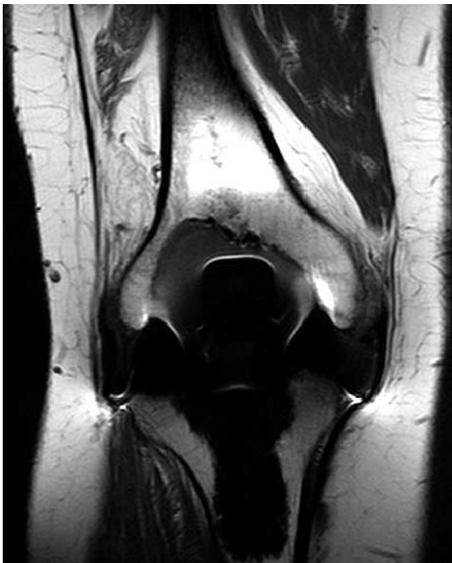
Fig. 2. Turbo spin-echo PD-weighted coronal image of the right knee of patient 1, demonstrating a large area of central lysis on the femur. No lysis is evident around the tibia.

MRI examinations of the knee were obtained using a Philips Intera 1.5-T magnet and a dedicated phased array knee coil (MRI Devices, Orlando, Fla). The MRI demonstrated large popliteal fluid collections around both knees, large joint effusions bilaterally, and an area of osteolysis in the central portion of the distal femur of the right knee (Fig. 2). At the time of revision surgery, severe polyethylene

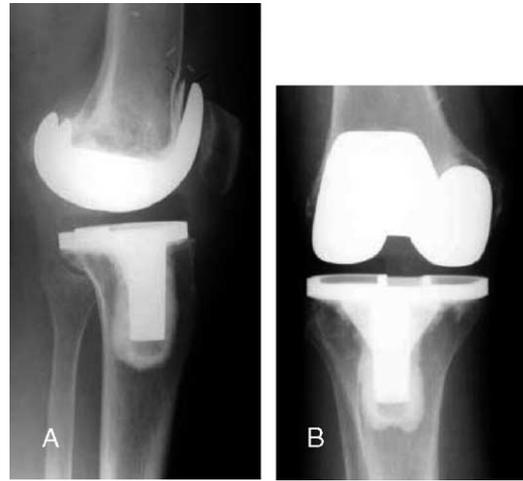
Fig. 3. A, Lateral x-ray demonstrating lift-off of the anterior flange of the femoral prosthesis because of loosening with little evidence of osteolysis on the femur or the tibia. B, Anteroposterior x-ray demonstrating mild osteolysis along the medial femoral condyle and proximal lateral tibia.

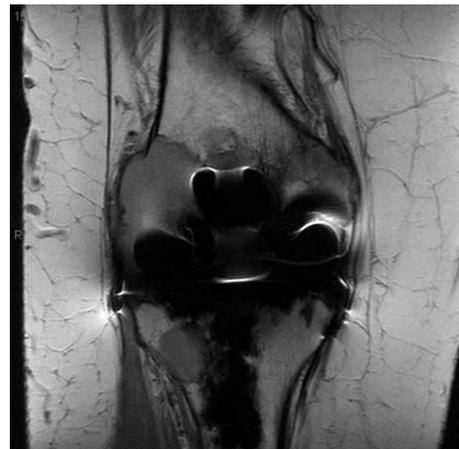
Fig. 4. Turbo spin-echo PD-weighted coronal image of right knee of patient 2, demonstrating a large area of osteolysis of the lateral and medial condyles of the femur and in the proximal lateral tibia.
